Simulation of the effect of auxiliary ties used in the construction of  
Mallorca Cathedral

ADVANCED MASTERS IN STRUCTURAL ANALYSIS  
OF MONUMENTS AND HISTORICAL CONSTRUCTIONS

## Master's Thesis

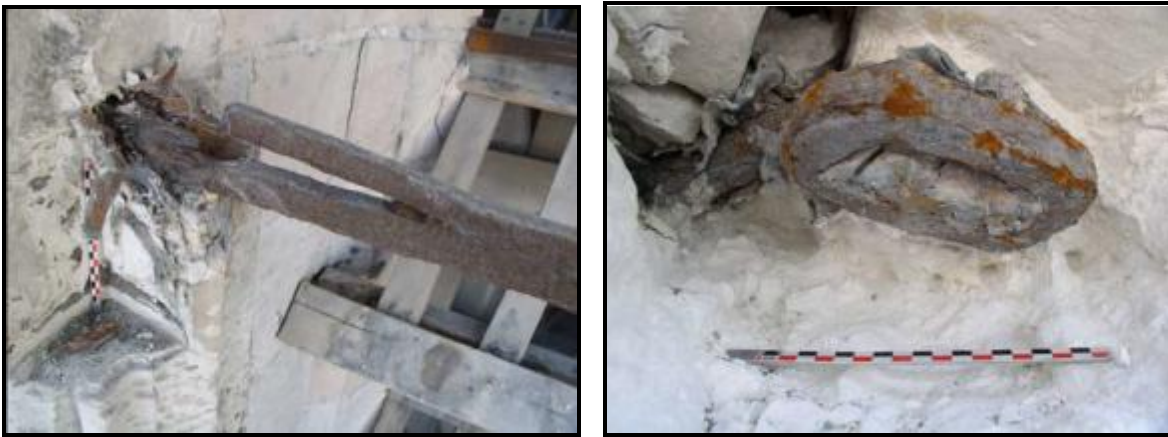
**Figure 13** – Church Saint-Ouen of Rouen: Example of a chaining system.

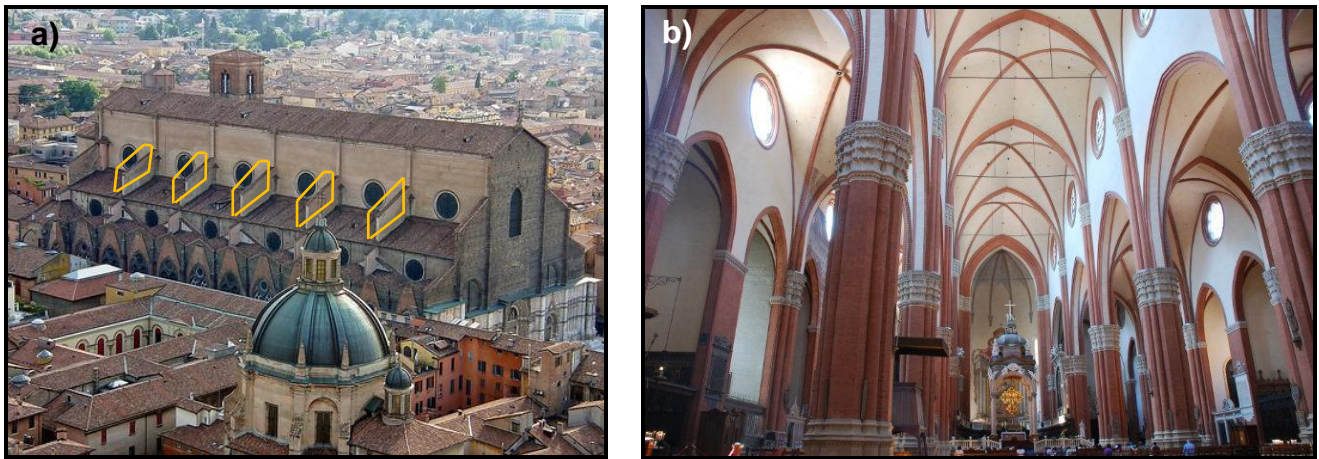
**Figure 33** – Basilica San Petronio, Bologna: a) outside; b) inside. Example of combined effect of buttresses and iron ties.

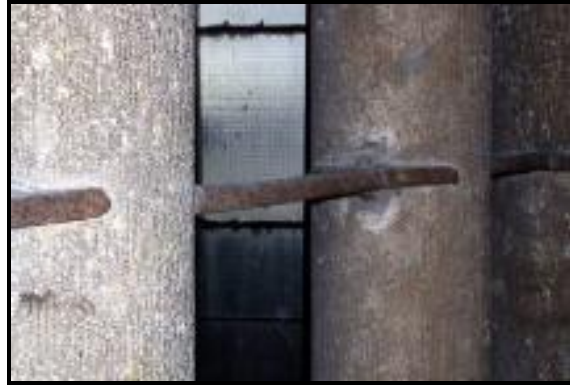
**Figure 37** – Rouen Cathedral : reinforcement of the small columns of the choir. (L'Héritier, 2007)

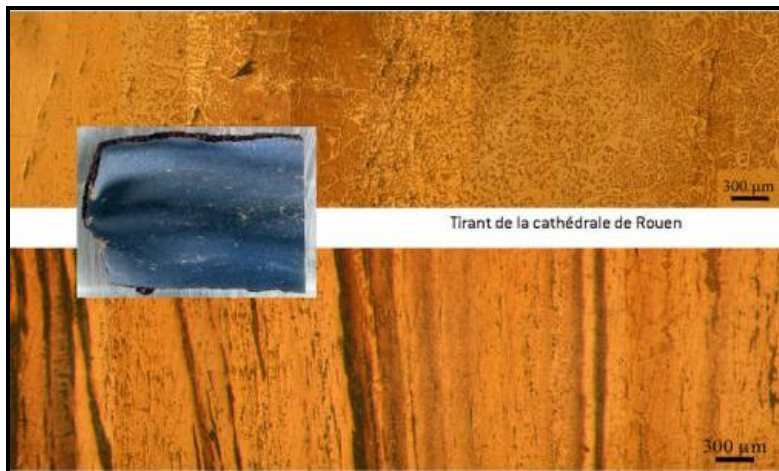
**Figure 42** – Cathedral Notre-Dame of Rouen: heterogeneity of a typical iron tie observed with a microscope.

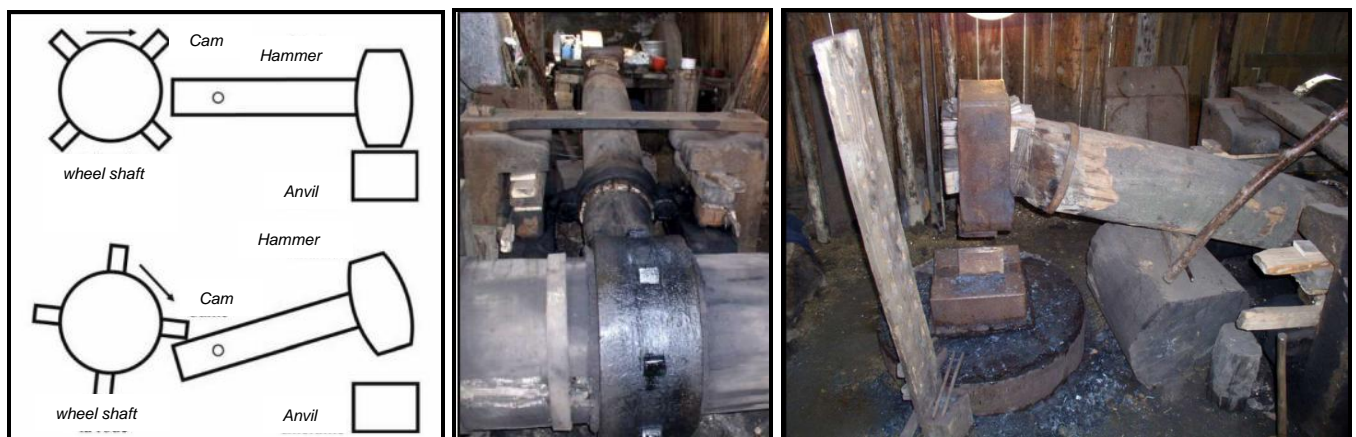
**Figure 44** – Hydraulic hammer principle from Rouillard, 2003 and example of a hydraulic hammer still in use in the smith of J. Brösl at Merdzev in Slovakia.

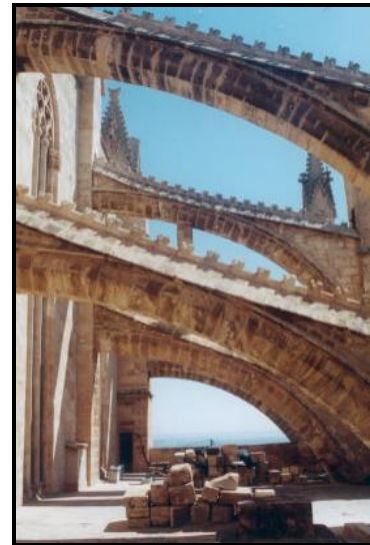
**Figure 56** – Double battery of flying arches. (Roca, 2001)

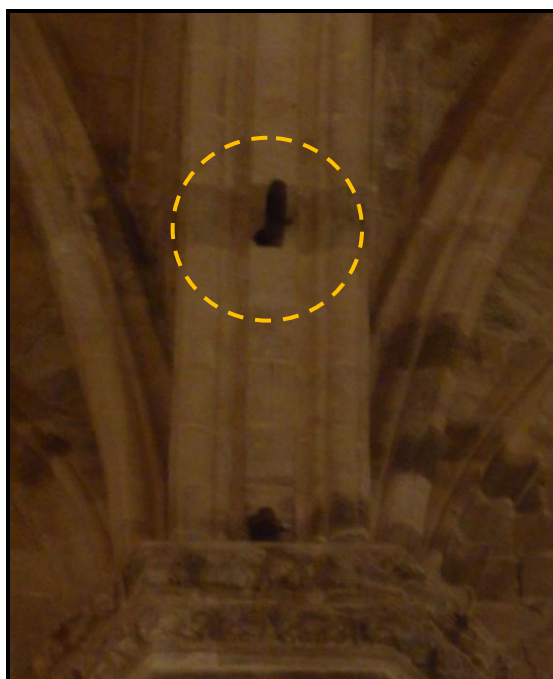
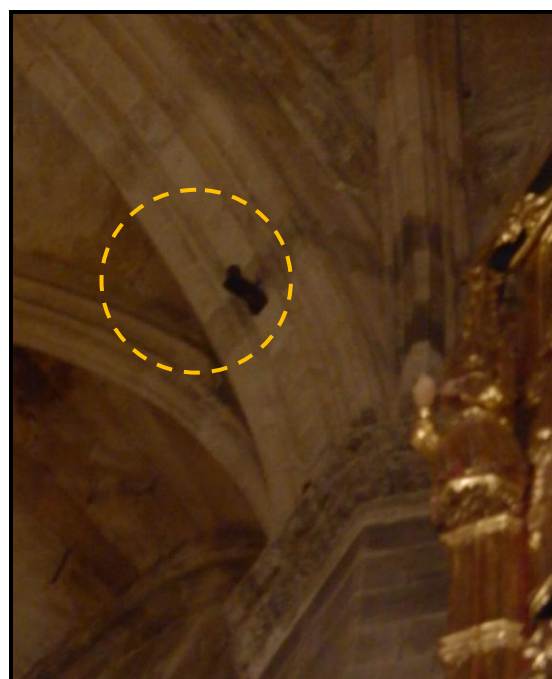
**Figure 81** – Southern nave, bay 4-5, exterior. Remaining iron hook attached to the vault.

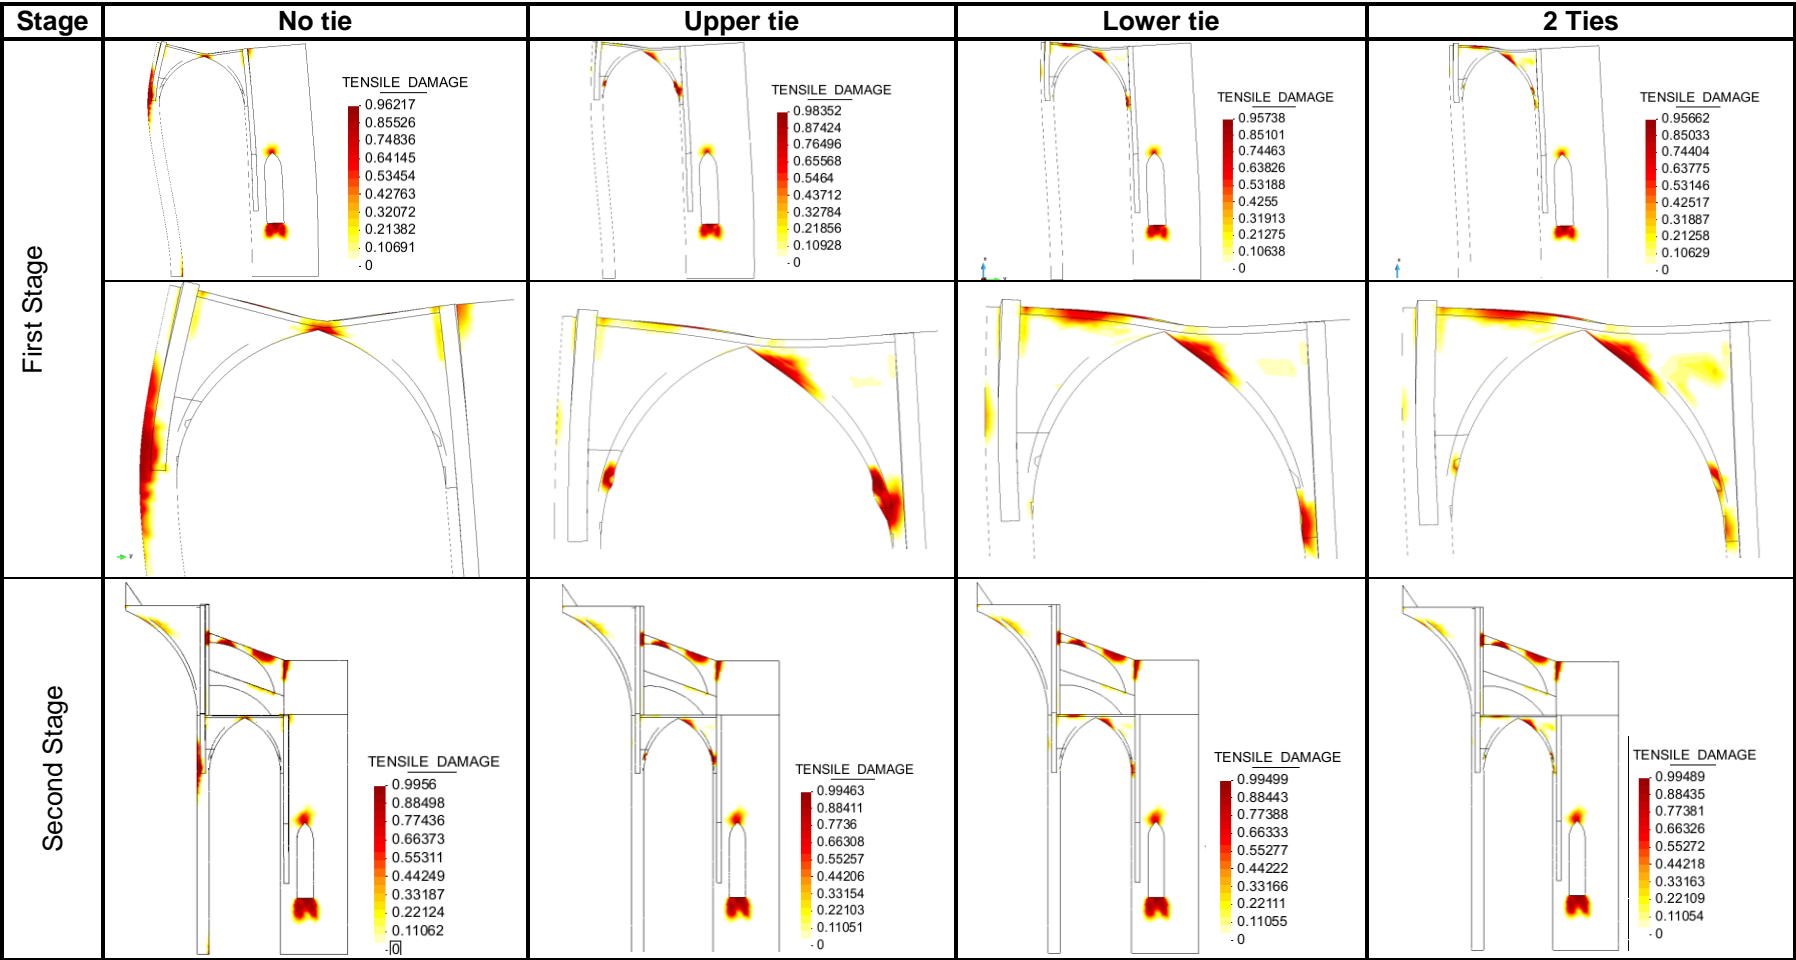
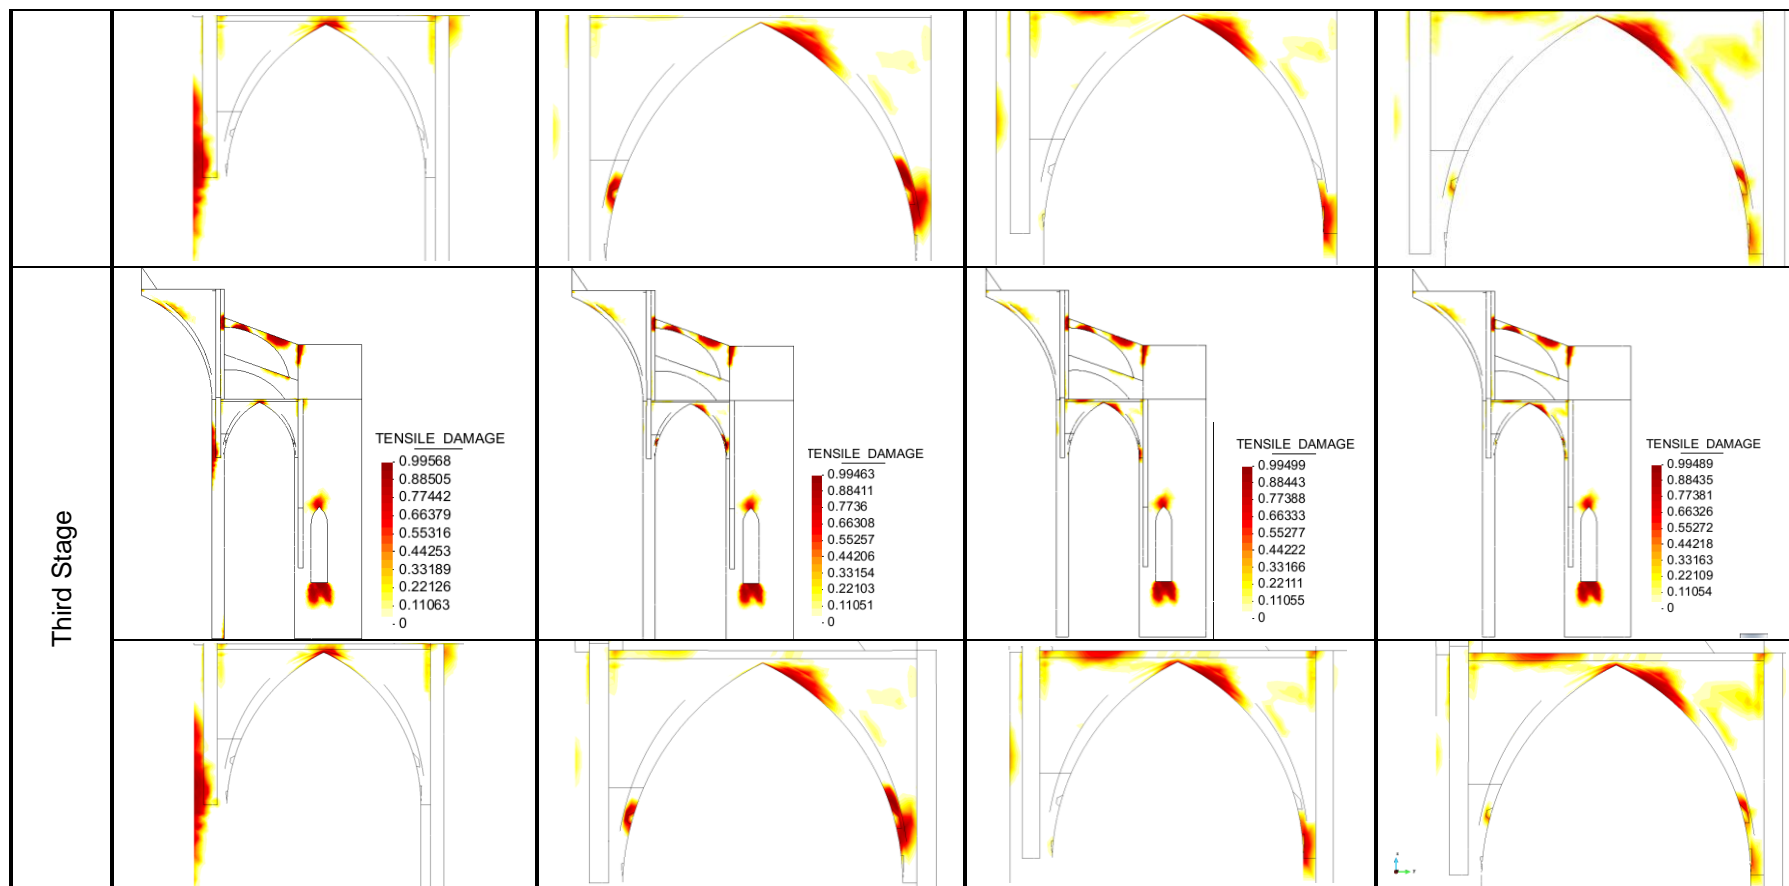
**ANNEX E: TENSILE DAMAGE AT STAGES 1, 2 AND 3 FOR THE FOUR DIFFERENT TIES CONFIGURATIONS UNDER THE ASSUMPTION OF SMALL STRAINS/LARGE DISPLACEMENTS. TIES AREA: 50 CM<sup>2</sup>.**
